## Analysis of deformation of breakwater during earthquakes

(Damage to a breakwater at Kobe port during 1995 Hyogoken-Nambu earthquake)

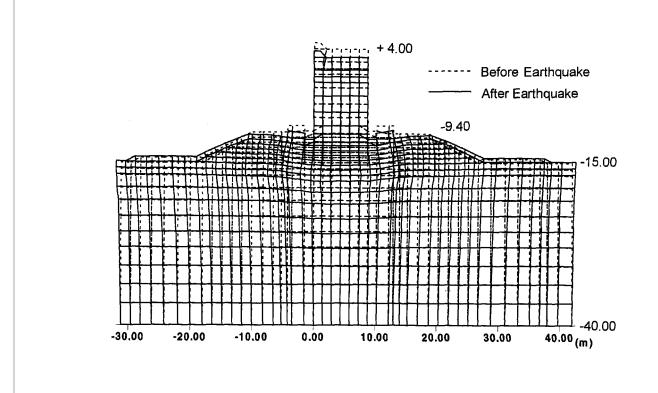
The analysis results in settlement of breakwater, associated with lateral spreading of rubble mound.
