# Analysis of deformation of caisson quay wall during earthquakes

Damage to caisson quay wall during 1995 Hyogoken-Nambu earthquake

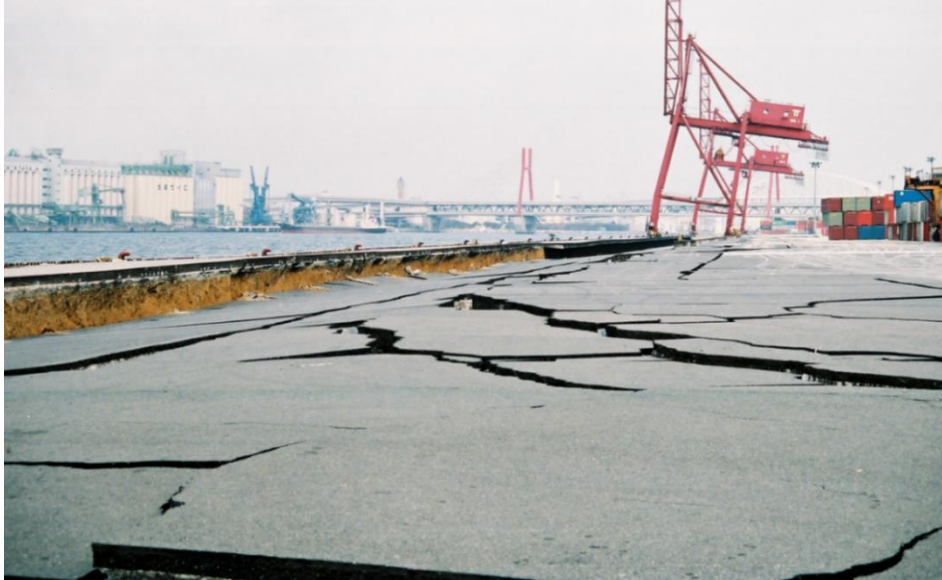
Caisson quay wall displaced 4 to 5 m toward the sea with a tilting of 4 to 5 degrees during 1995 Hyogoken-Nambu earthquake (as shown in upper figure). FLIP program can reasonably simulate this type of damage (as shown in lower figure).
