Analysis of deformation of deep foundation (pneumatic caisson foundation) during earthquakes

Damage to Kobe Ohashi Bridge during 1995 Hyogoken-Nambu earthquake is analyzed.

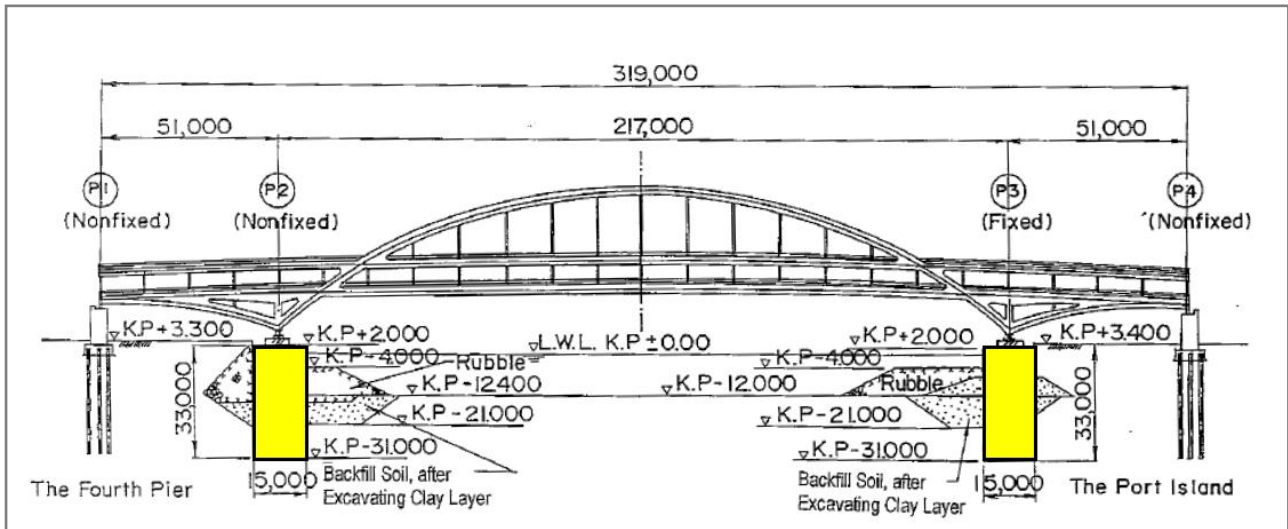
Yellow marker indicates large pneumatic caisson foundation (33m from top to bottom).

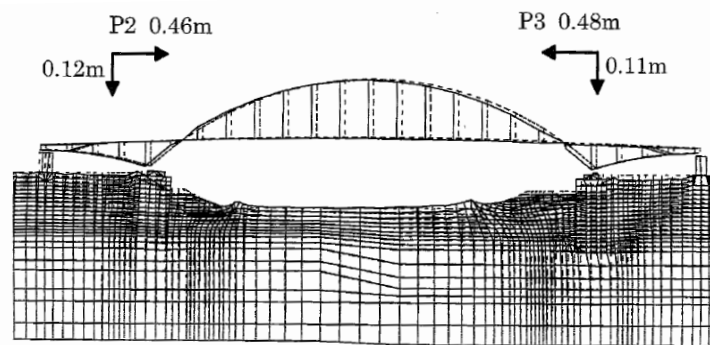
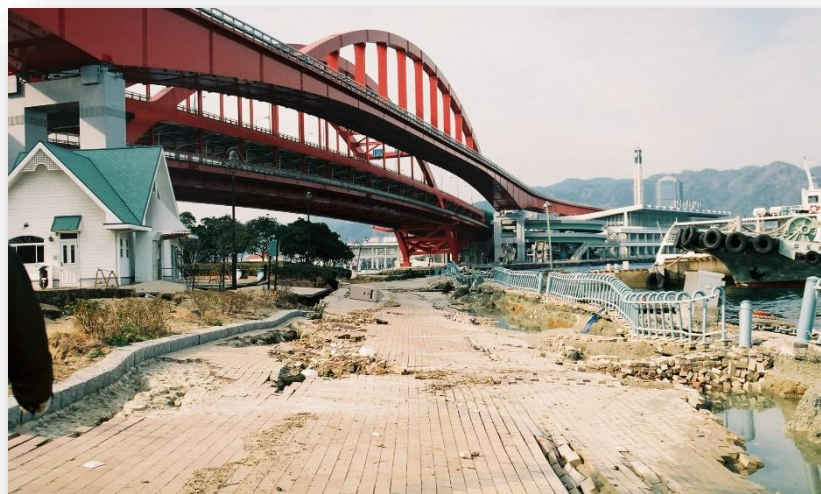
Damage to Kobe Ohashi Bridge during 1995 Hyogoken-Nambu earthquake
